April 18, 2023

**IMPORTANT SAFETY NOTICE: REQUIRED RETURN OF AFFECTED KLAUKE ORANGE TOOLS  
PRODUCED FROM DECEMBER 2021 TO JANUARY 2023**

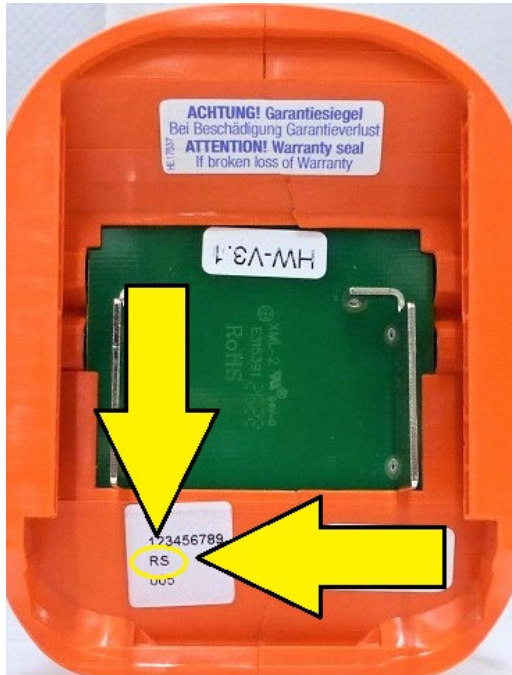
Figure 1 – Date Code Location

**STEP 1** – Remove the battery from the Orange Tool unit in question and identify the two character Date Code listed on the second row on the serial number label, as pictured below (see, Figure 1).

**STEP 3** – If the two character Date Code listed on the second row of the serial number label appearing are: **Q1, RN, RP, RQ, RR, RS, RT, RV, RW, RX, RY, RZ, R1** or **SN**, and no Green Dot is present your Orange Tool is affected and must be returned to Klauke. Do not continue to use or sell the Orange Tool. Contact Klauke using the information provided below.

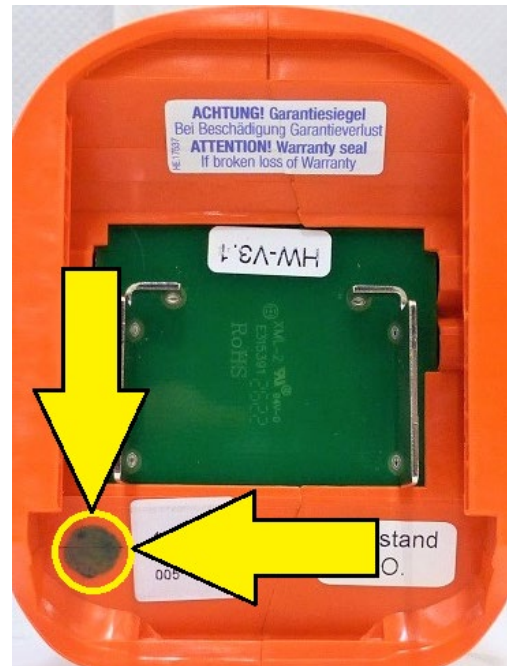
Figure 2 – Green Dot Location

**STEP 2** – look for the presence of a Green Dot in the corner next to the serial number label (figure 2)

This announcement is not applicable if your unit contains a Green Dot in the corner next to the serial number label and your Orange Tool falls into the possibly affected product range. In this case your unit has already been reworked by Klauke. If your unit's date code does not fall into the above date range your unit is also not affected by this announcement.
